**DEVELOPMENT OF ADVANCED FABRICATION TECHNIQUES
FOR REGENERATIVELY COOLED THRUST CHAMBERS
BY THE GAS-PRESSURE-BONDING PROCESS**

October 6, 1970

**BATTELLE MEMORIAL INSTITUTE
COLUMBUS LABORATORIES**

FINAL REPORT

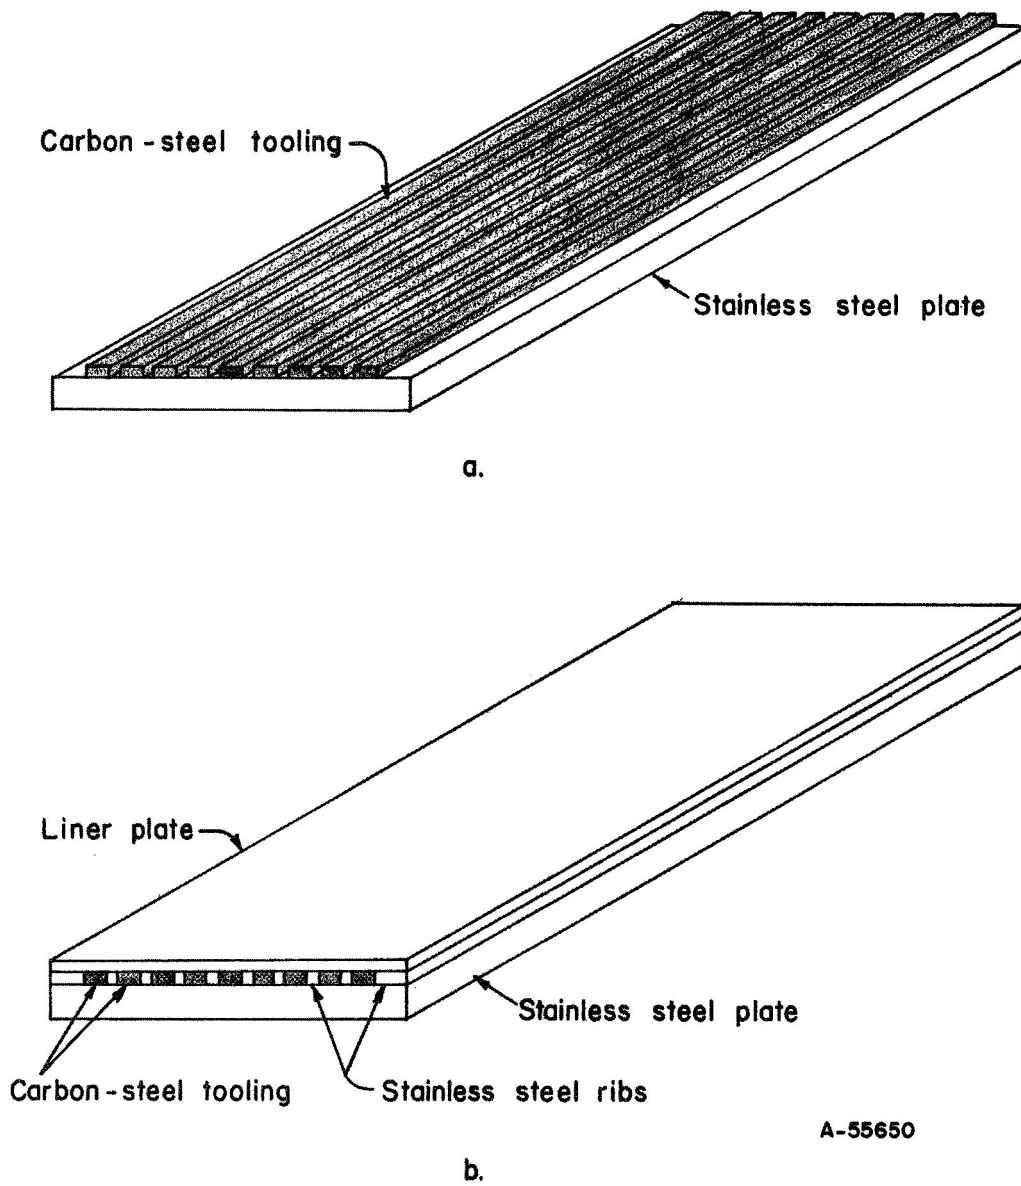
FIGURE 1. FLAT-PANEL-SPECIMEN APPROACH

The flat-panel-specimen approach used in Task I is illustrated in Figure 1. To further develop the fabrication methods and demonstrate the fabricability of a simulated chamber, cylindrical spool pieces were constructed in Task II. A typical assembly is shown in Figure 2. The third phase of the program was to involve the construction and fabrication of segments of a thrust chamber as illustrated in Figure 3, but owing to revisions in contract objectives, Task III was omitted from the program.

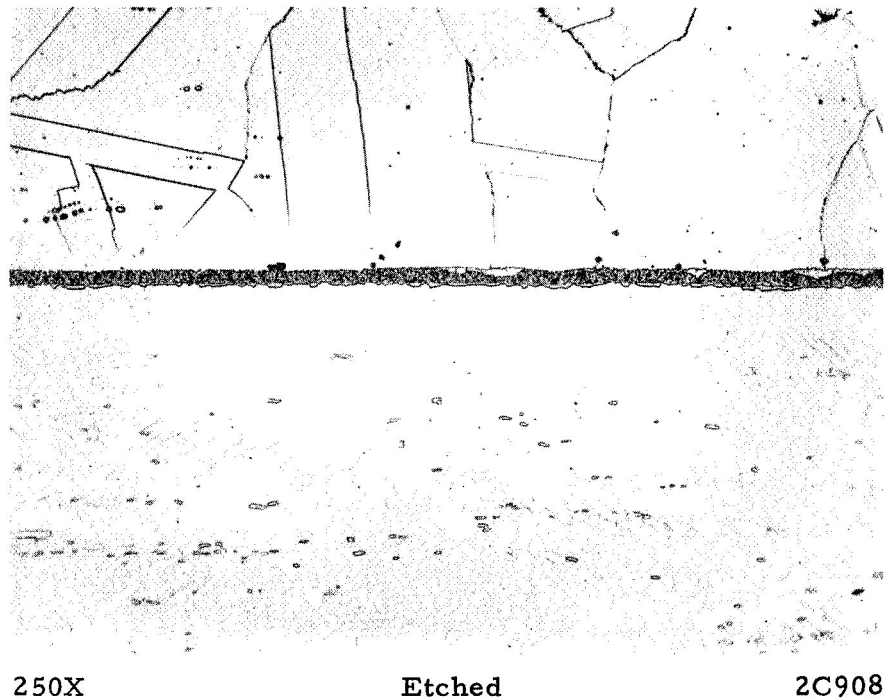
FIGURE 5. TD NICKEL BONDED TO STAINLESS STEEL USING
A TUNGSTEN INTERMEDIATE LAYER

Since HNO_3 was to be used to leach the tooling away from the TD nickel, this liner material had to be protected from attack. Tungsten foil (0.0005 inch) was evaluated as a possible protective layer. Figure 5 shows a stainless steel/tungsten/TD nickel bond. The bond appears sound. In the case of the carbon steel, the tungsten separated from the TD nickel. Also, there was a considerable amount of diffusion in the carbon steel. After a 6-hour heat treatment at 2200 F, the stainless steel/TD nickel bonds were unchanged. However, the tungsten rebonded to the TD nickel. A second protective coating investigated was electroplated chromium. The plating procedure is summarized in Table 5. This appeared to work quite well; the tooling could be leached readily from the TD nickel yet the liner material appeared to be protected from attack. Also, the electroplating approach was simpler from a fabrication and assembly standpoint.

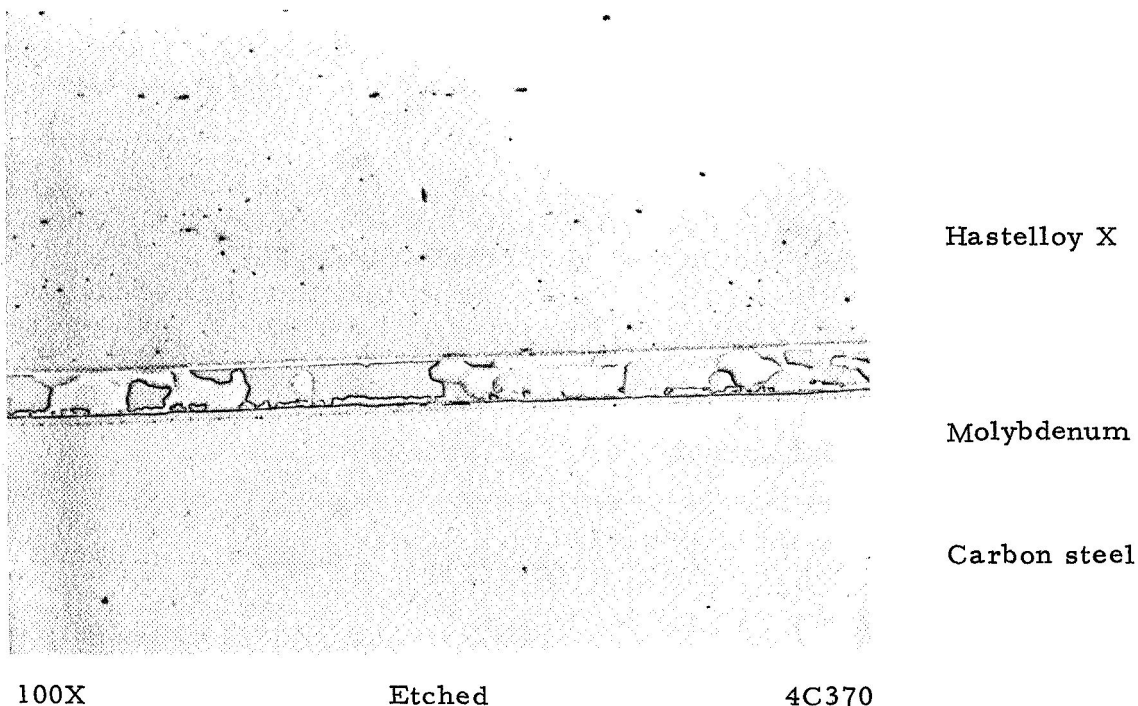
FIGURE 6. HASTELLOY X BONDED TO CARBON STEEL WITH A MOLYBDENUM INTERMEDIATE LAYER

To prevent nickel diffusion from Hastelloy into the tooling, a molybdenum foil was inserted at the interface; a typical bond is shown in Figure 6. The molybdenum effectively blocked interdiffusion, and could be readily removed in HNO_3 . No attempt was made to evaluate the bond strength or bond quality at this point since the sole purpose of the molybdenum foil was to prevent interdiffusion between the Hastelloy X and the carbon steel. Owing to design revisions later in the program (during Task II studies), it became necessary to achieve a good metallurgical bond between the molybdenum and the liner and tooling components. This requirement was not recognized, nor were the difficulties arising from inadequate bond strength of the molybdenum-liner couples foreseen until after the cylindrical spool pieces had gone through the bonding cycle. This problem is discussed in detail under Task II studies.

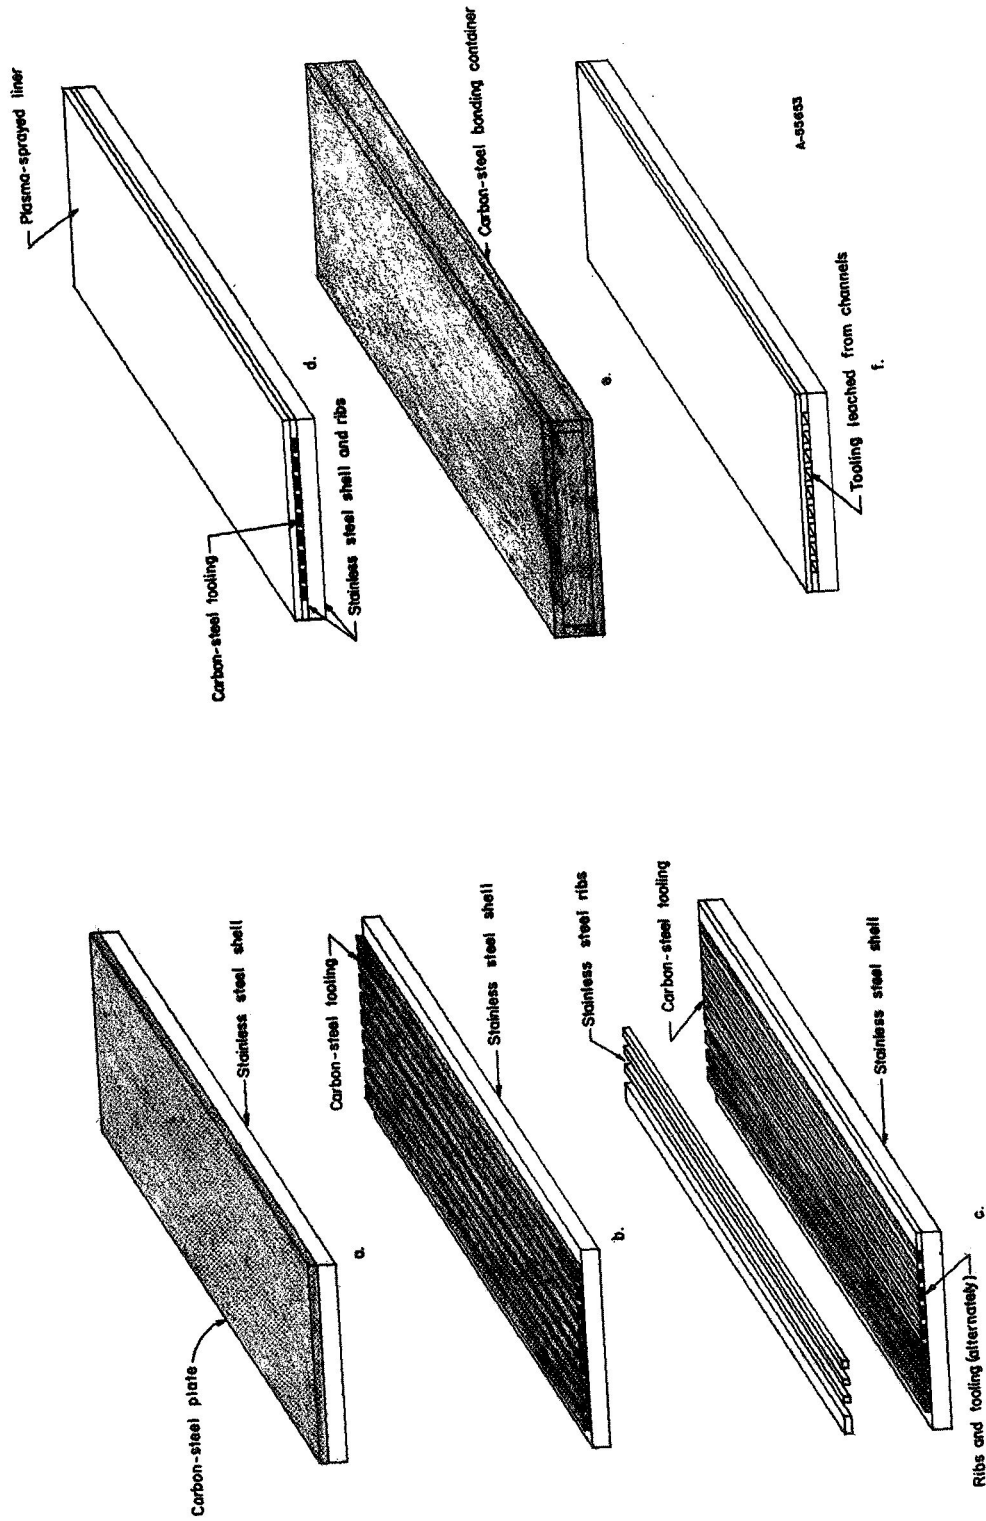
FIGURE 7. FLAT-PANEL-SPECIMEN ASSEMBLY

The bonded shell-tooling assembly showed a slight curvature as a result of the unbalanced condition, i.e., carbon steel on only one side of a stainless steel plate.

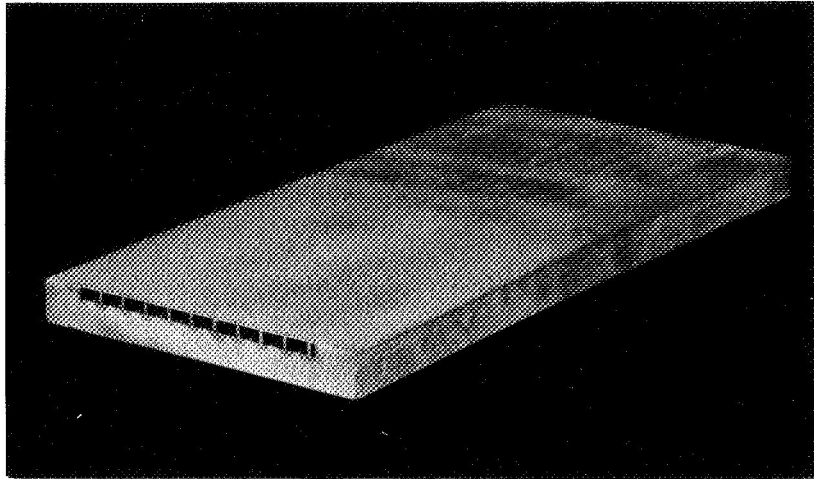
FIGURE 15. FULL-SIZE FLAT-PANEL SPECIMEN OF FIRST GROUP

Specimen F3 is shown here after gas-pressure bonding at 2200 F and 15,000 psi for 3 hours. The tooling within the channels was removed with nitric acid.

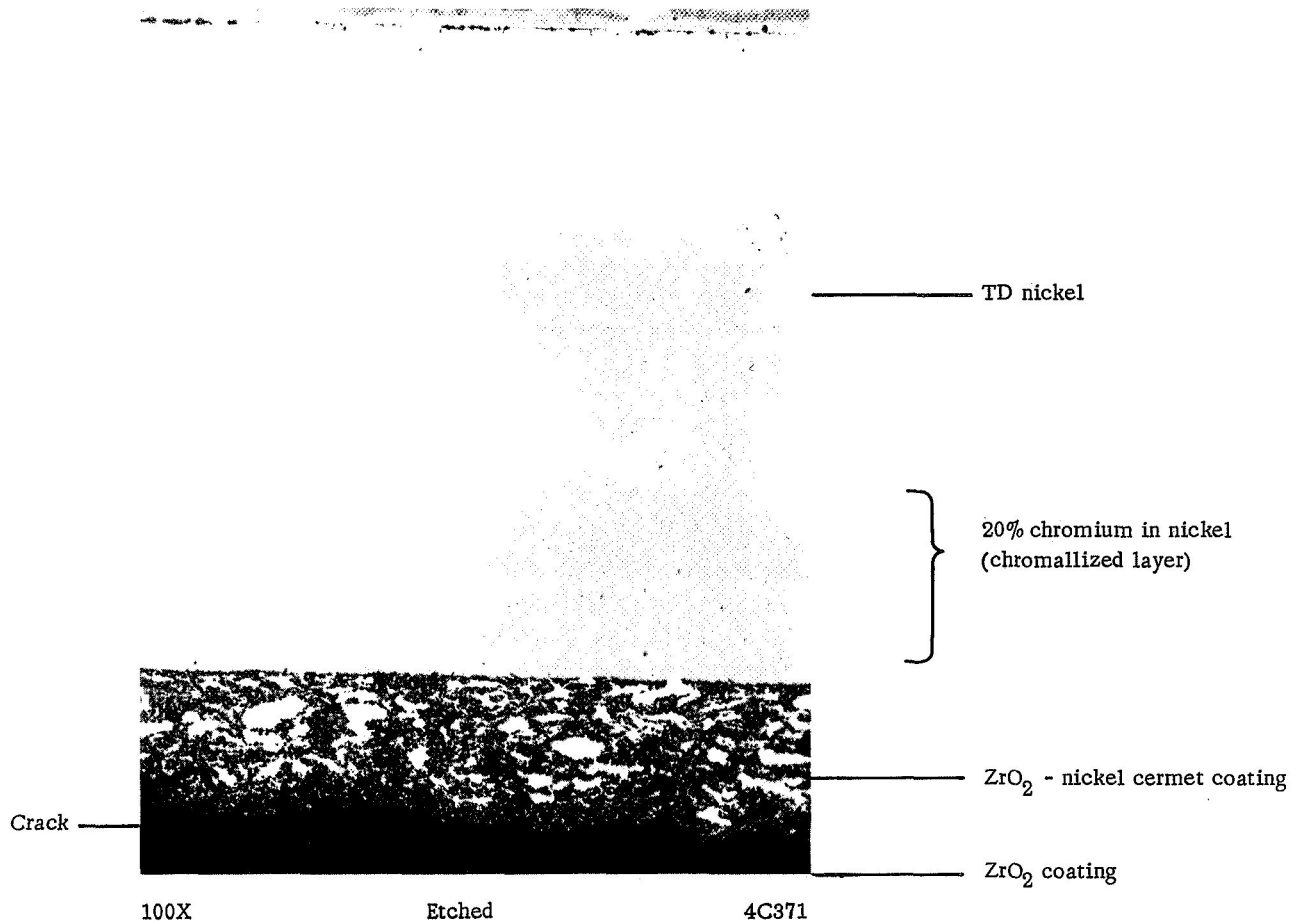
FIGURE 23. ZrO_2 GRADED COATING BONDED TO CHROMALLIZED TD NICKEL

Later in the program, it was found that the oxide coatings could be bonded directly to the liner materials. This was accomplished with the aid of a friable layer, in this case an aluminum silicate felt (Fiberfrax), which was placed between the can material and coating. The specimen liners were prepared by mechanical abrasion. The oxides were placed on the liner plates by mechanical means rather than by plasma spraying, and a layer of Fiberfrax felt was inserted between the ceramic and the bonding container. During cooling from the bonding conditions, the Fiberfrax fractured and caused a separation between the oxide and container. Thus, the oxide coating had only to adjust to the thermal-expansion differences of the liner.

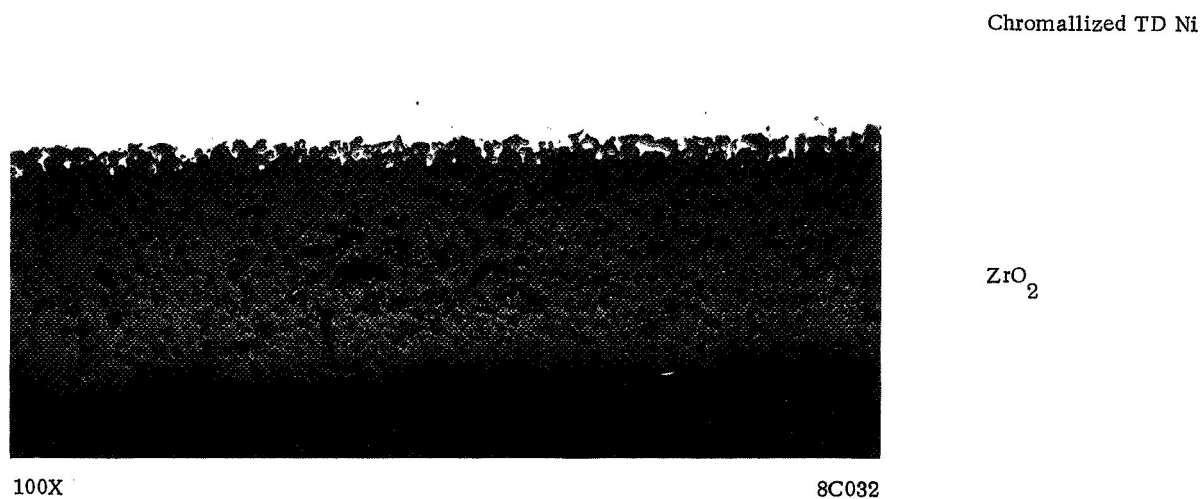
FIGURE 24. ZrO_2 COATING BONDED TO CHROMALLIZED TD NICKEL

The oxide powder was applied mechanically rather than plasma sprayed. Some porosity in the oxide is evident. The oxide penetrated the metal surface and produced strong mechanical bonds as well as chemical bonds.

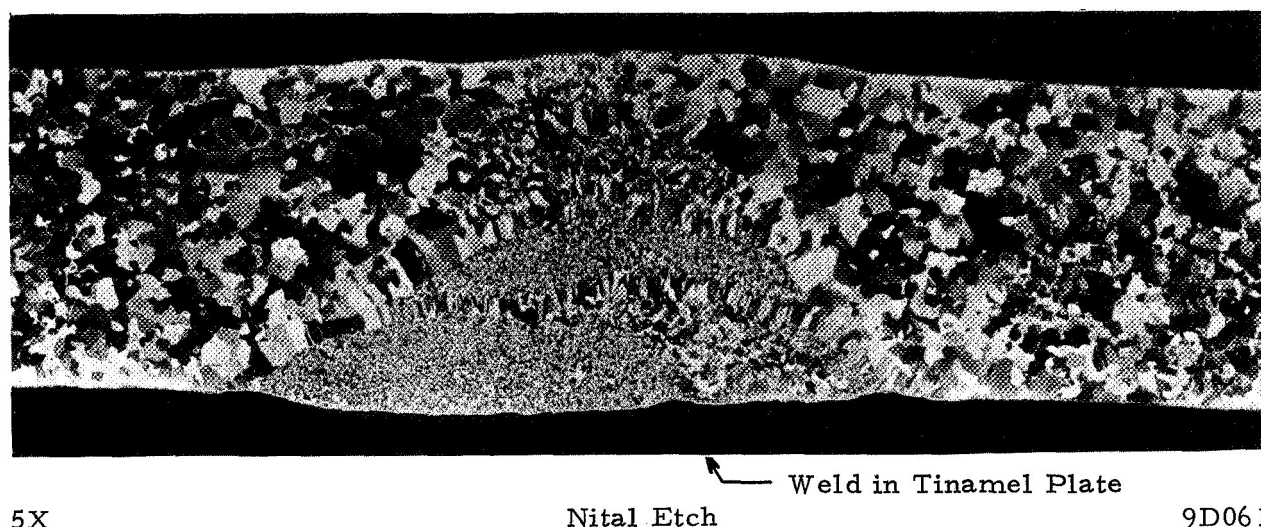
FIGURE 26. WELD IN TINAMEL TEST PLATE AFTER EXPOSURE TO SIMULATED AUTOCLAVE CYCLE AT 2300 F FOR 3 HOURS

The joint design for the sleeve closure was a 90-degree level with a 1/16 inch land. Eight passes were required to fill the joint. A weldment composed of Tinamel base plates with silicon-killed steel filler were subjected to a simulated autoclave cycle. The weldment was heated to 2300 F, held for 3 hours, and furnace cooled. The specimen was then sectioned for metallographic examination. No detrimental effects were observed. A typical section is shown in Figure 26. The grain size of the material in the final weld passes was smaller than the initial grain size, because of the greater content of filler material in this area.

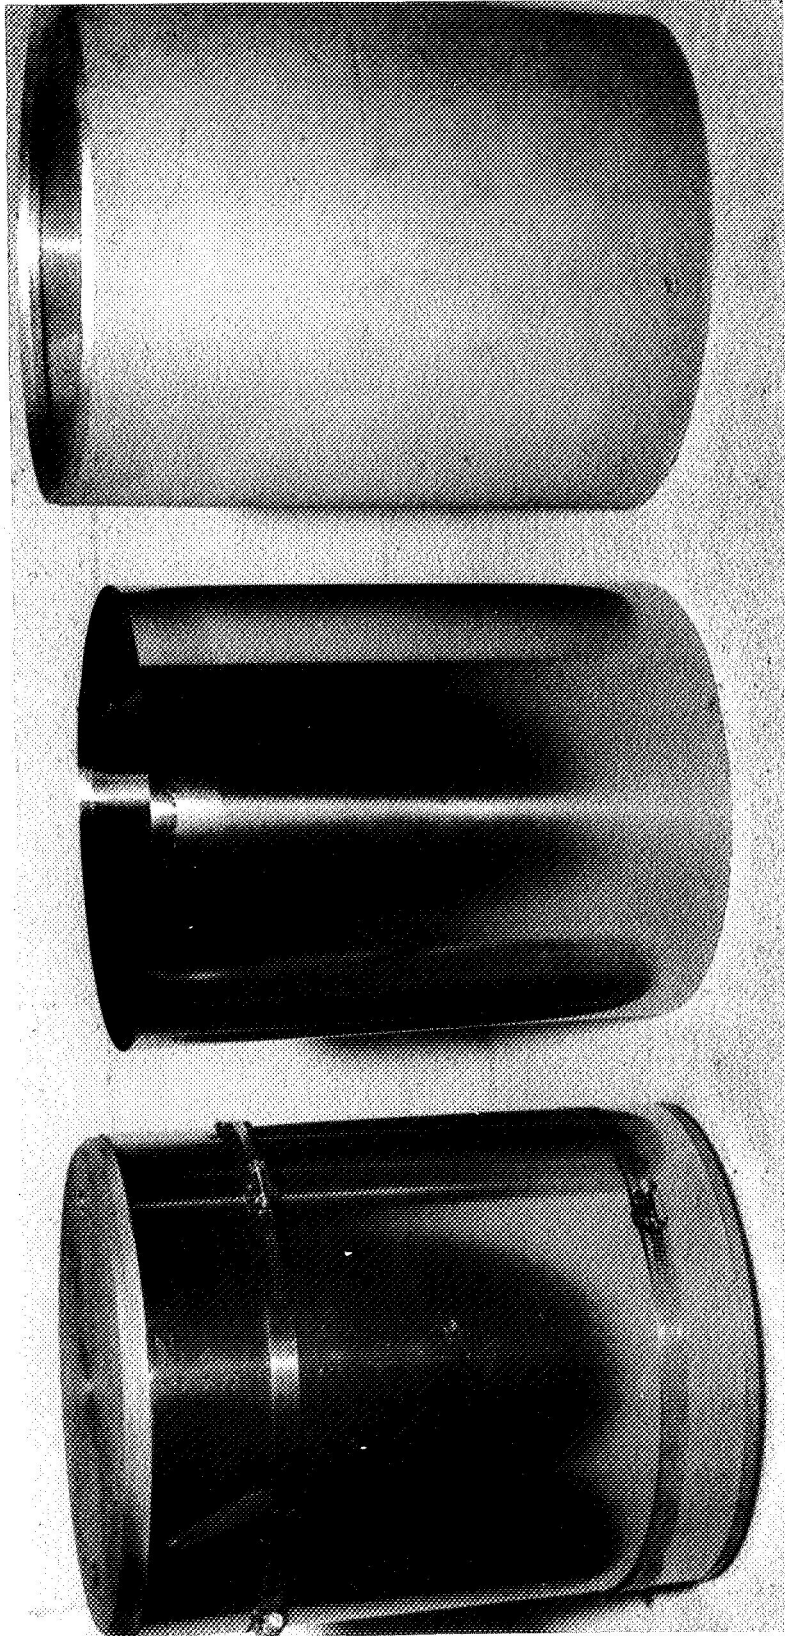
FIGURE 27. SPOOL-PIECE COMPONENTS PARTIALLY ASSEMBLED

Initial attempts to assemble the TD nickel liner and inner molybdenum foil around the steel mandrel of Specimen No. 2 were frustrated by slight warpage and increased dimensions of the liner due to the chromium diffusion treatment. This was corrected by filing the overlapping edges to the proper dimensions. To prevent initiation of micro-cracks in the hard liner surface by this corrective measure, only light strokes in one direction with the face of the file flat against the edge of the liner were permitted. Subsequent cleaning of the components and the assembly were accomplished without further difficulty.

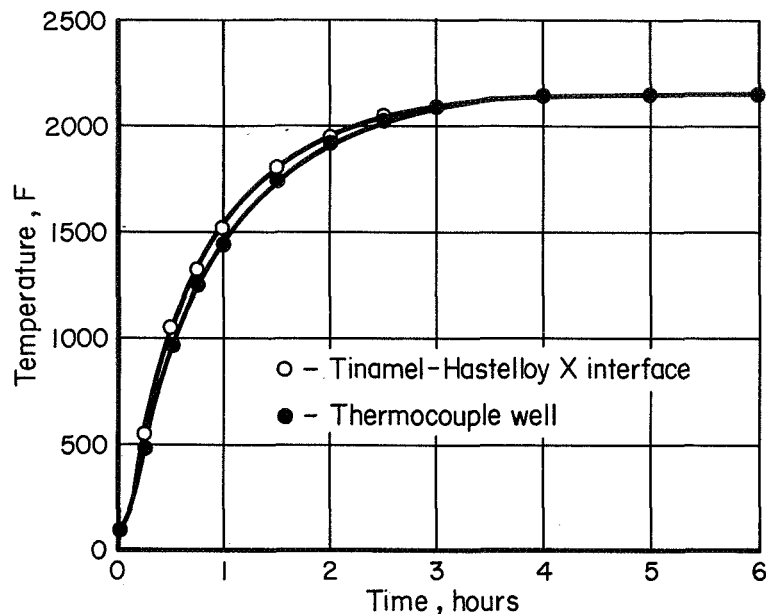
FIGURE 33. PREDICTED CHANGE IN TEMPERATURE OF COMPONENTS IN SPOOL SPECIMENS DURING GAS-PRESSURE BONDING

Within 2 hours the liner components inside the shell should be at 1900 F. Within 3 hours these same points are within 15 degrees of 2100 F. The components reach a steady temperature of 2140 F in about 5 hours. In the actual bonding cycle, the surface temperature was raised gradually to 2150 F so that the internal components could reach a stable temperature near 2150 F in much less time than predicted by the thermal study once the skin temperature reached 2150 F. Then, to assure that adequate diffusion between components occurred, particularly between the 347 stainless steel ribs and the liner, the specimens were subjected to a temperature of 2150 F for at least 4 hours.

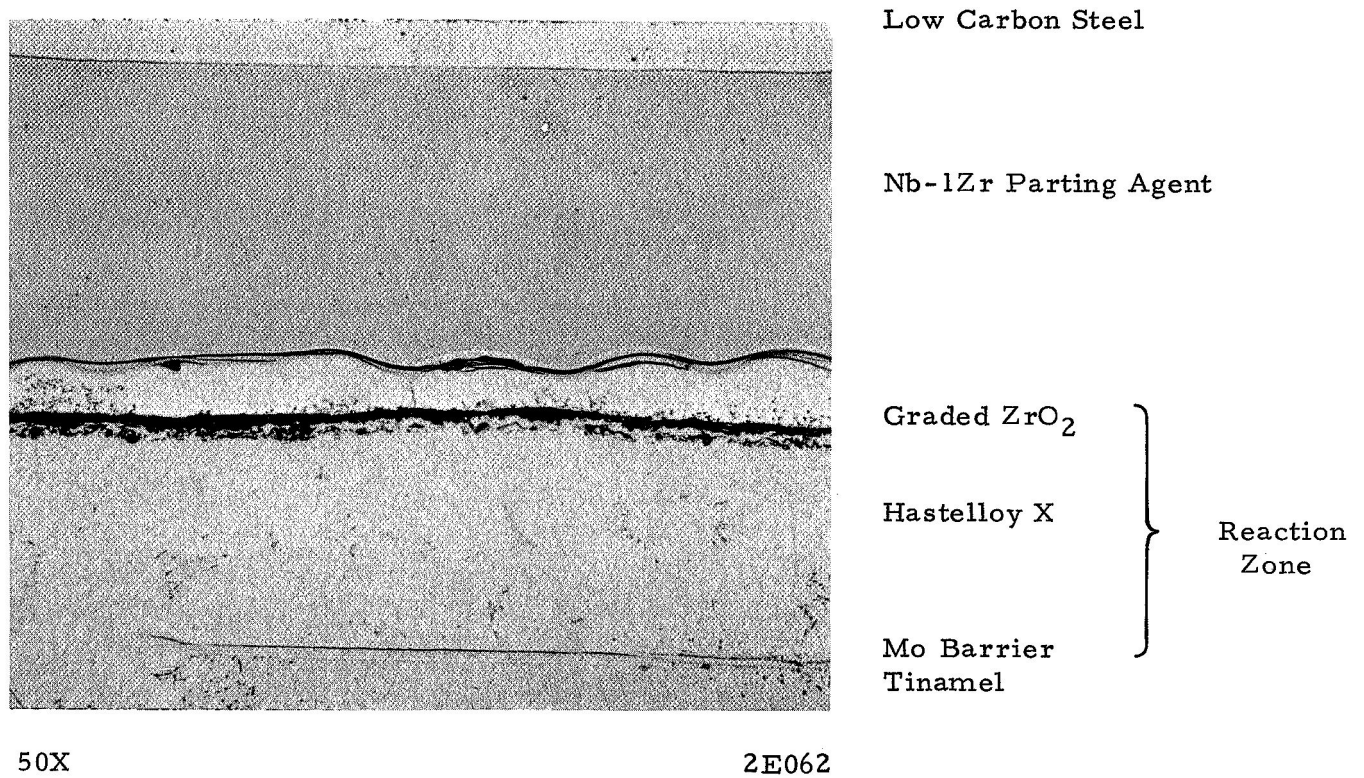
FIGURE B-5. SPECIMEN C-6, SECTIONED IN CONTAINER, SHOWING PREFERENTIAL CRACK AT Nb-1Zr/ ZrO_2 COATING SURFACE

These coatings remained sound and the cracks occurred at or near parting agent.

Gross reaction between components and embrittlement of Nb-1Zr parting agent obscured useful results in this specimen.

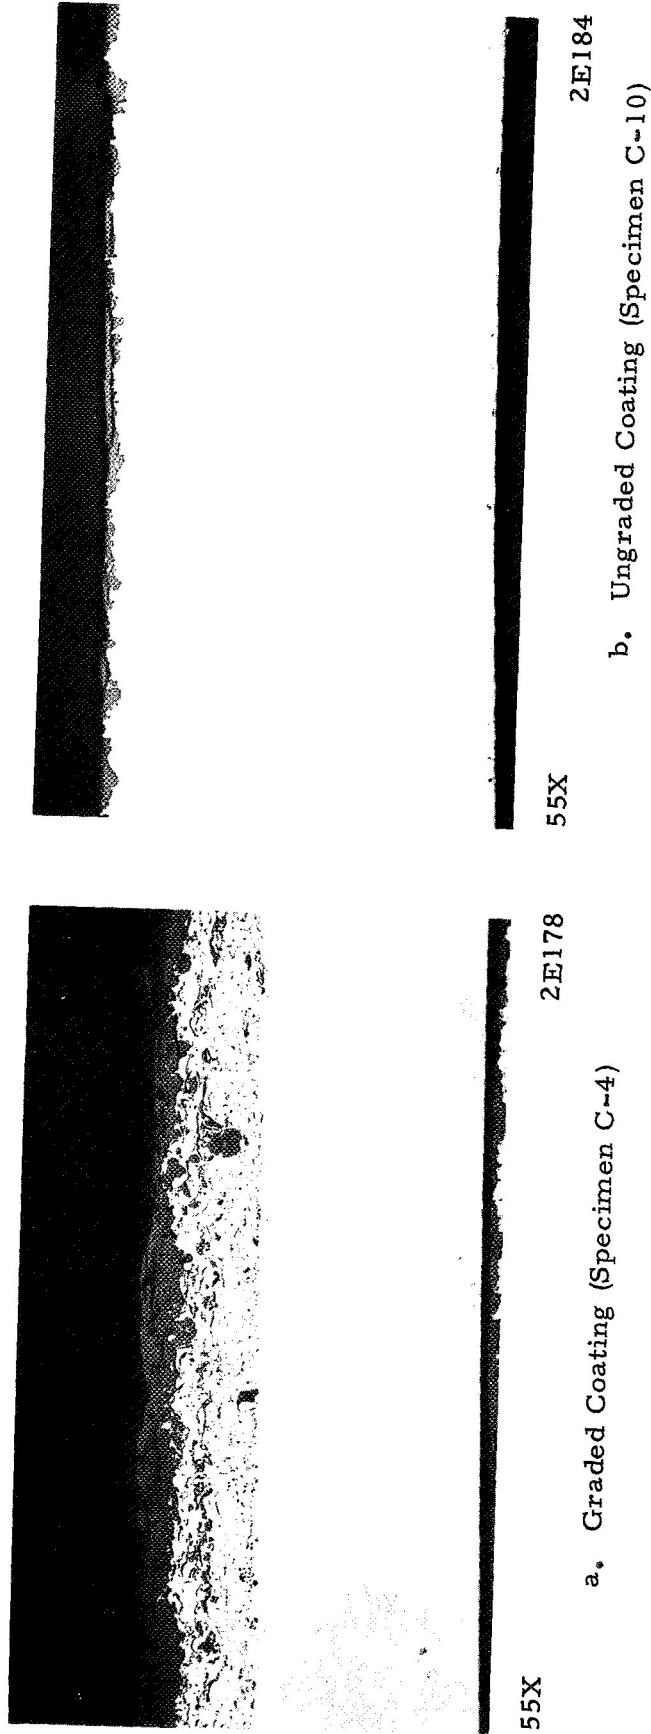
FIGURE B-10. OXIDE-COATING TEST SPECIMENS C-4 AND C-10

Parting layer was magnesia.

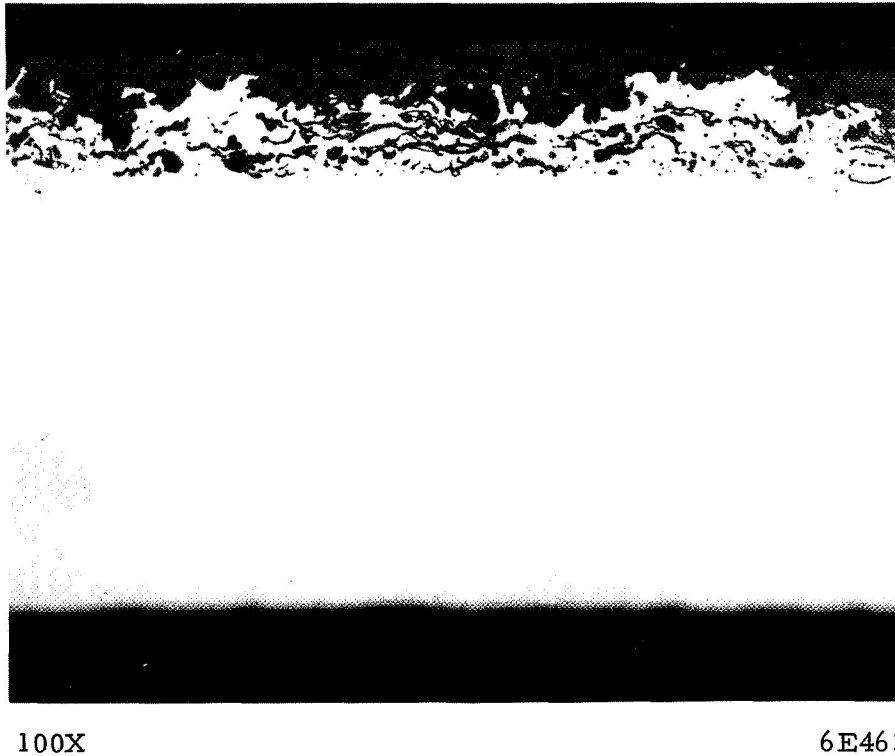
FIGURE B-17. GRADED OXIDE COATING ON HASTELLOY X AFTER THERMAL-SHOCK TESTING (SPECIMEN C-2)

Most of the coating remained bonded to the Hastelloy X substrate. Some lamellar-type cracks developed because of thermal shock, but these were not severe.

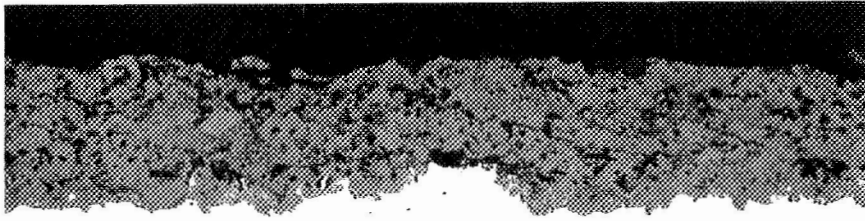
100X

FIGURE B-20. UNGRADED OXIDE COATING ON LARGER (4 BY 8-INCH)
HASTELLOY X PLATES

Both plates had a residue of the alumina parting layer on top of the zirconia coating and gave a lighter color shade to the surfaces. The alumina flaked off easily, leaving the strongly adherent, beige-colored zirconia. The dark corners are residue iron which was not completely leached off but which could be peeled off from the oxide surface. The shading figure at the midregion of the bottom plate appeared to be a plasma-spraying artifact.

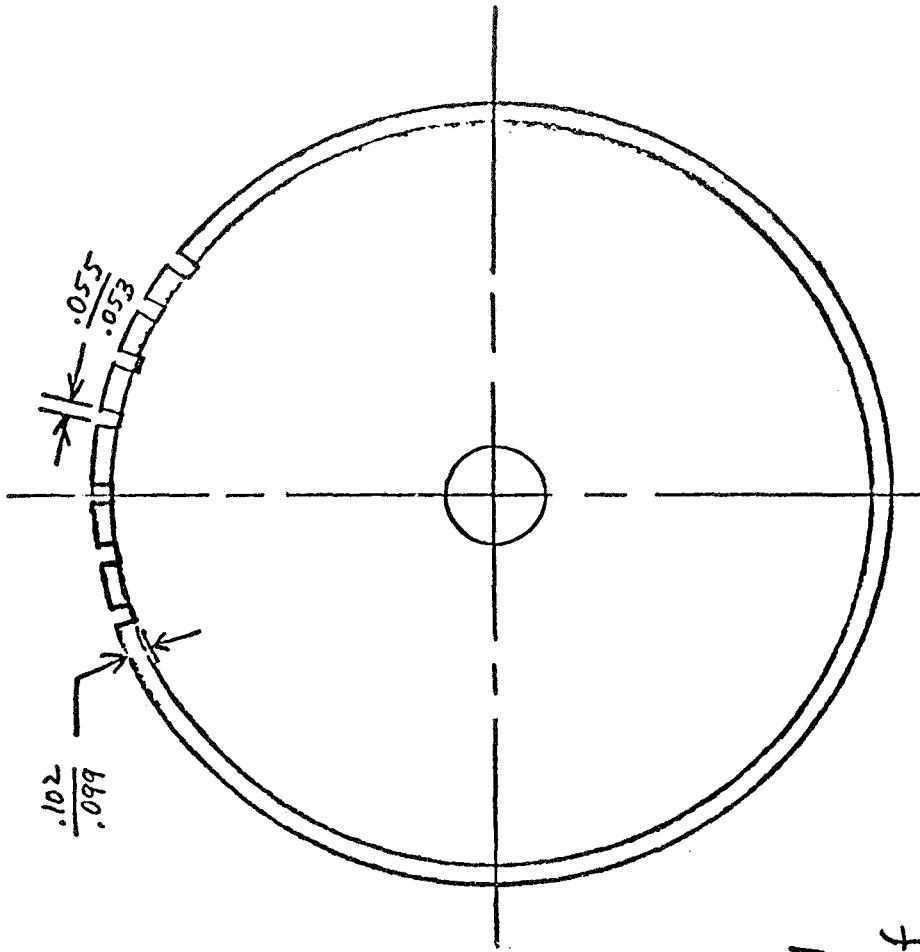
SK 8635-C

120 Slots,
Eq. Spaced
